# THE DEVELOPMENT OF A NEW CLASS OF TWO-WHEELER VEHICLES

BMW AG

Paper Number 01-S8-O-475

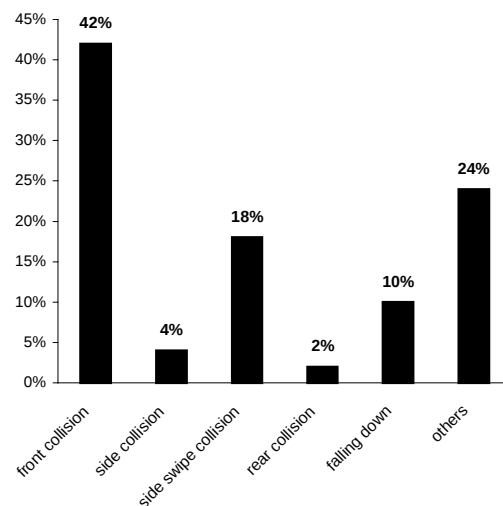
**Figure 2. Motorcycle types of collisions**

As in the case of passenger cars, a large proportion of the safety concept requirements were derived from real-life accident events. Several hundred motorcycle accidents have been analysed at BMW. In considering the nature of the collision, the clear leader was the frontal collision, accounting for around 42%. Side and rear collisions at 4% and 2% may be regarded as being of relatively minor significance (Figure 2).

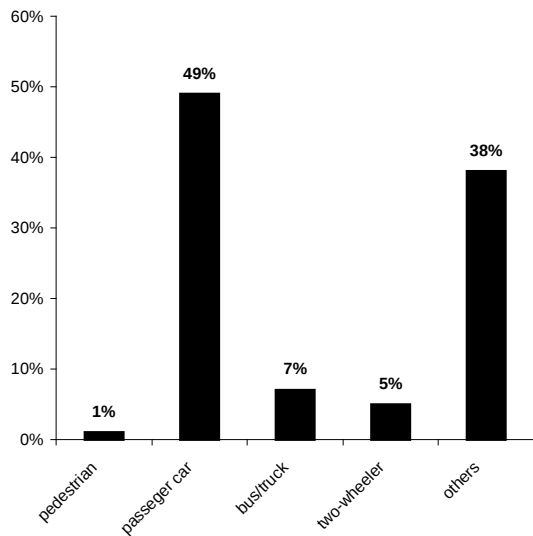
**Figure 3. Opposing vehicles in accidents**

The most frequently struck object in a motorcycle accident is the car, which accounts for 50% of cases (Figure 3).

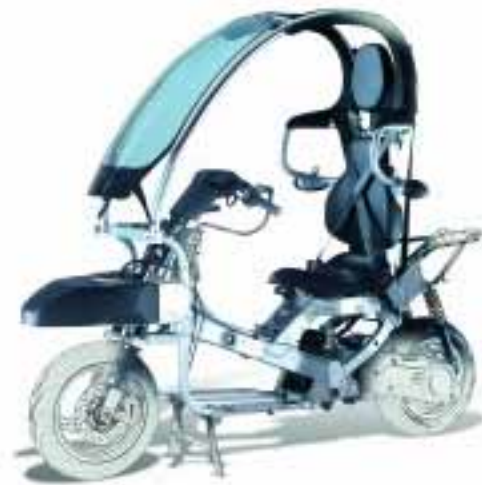
**Figure 4. Safety frame**

The aluminium space-frame design chosen for the C1 (Figure 4) comprises a main frame, roof frame and bolted shoulder hoops. Maintaining the safety cell required to protect the rider makes high demands on the frame structure, particularly in the case of serious accidents. The loads acting from outside are countered by a suitably rugged frame structure. In addition, the main frame in combination with the shoulder hoops absorbs the belt forces generated in a crash. The belt anchor points have been tested using the static belt pull test. The shoulder belt and the three-point belt are tested individually. The C1 frame is firmly clamped and the belts are stressed to 6.75 kN for a period of 200 ms (Figure 5).

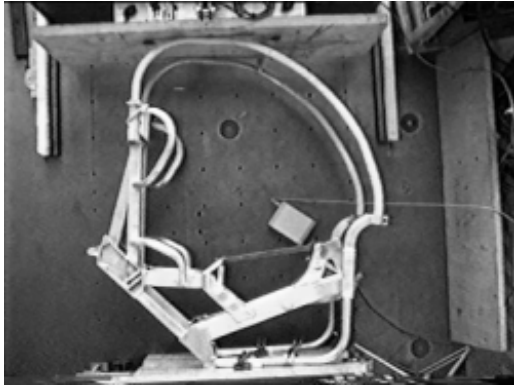
**Figure 6. Roof crush test**

The roof frame is subjected to a modified FMVSS 216 crush test. In accordance with this standard, the structure is placed under load in a quasi-static condition. The frame must withstand a load of 22 kN with a max. deformation of 127 mm (Figure 6).

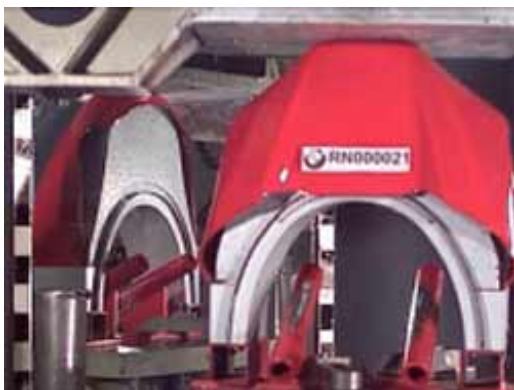
**Figure 7. Drop test**

To keep the load on the rider to a minimum, a rigid polypropylene foam element is mounted level with the centre of gravity. This foam element is capable of up to 300 mm deformation and together with the telelever acts in the same way as the crumple zone of a motor car. The location of the foam element also resist the pitching moment developed during impact. In order to tune the foam body and the telelever, a drop test was carried out to simulate a collision with a stationary motor car (Figure 7).

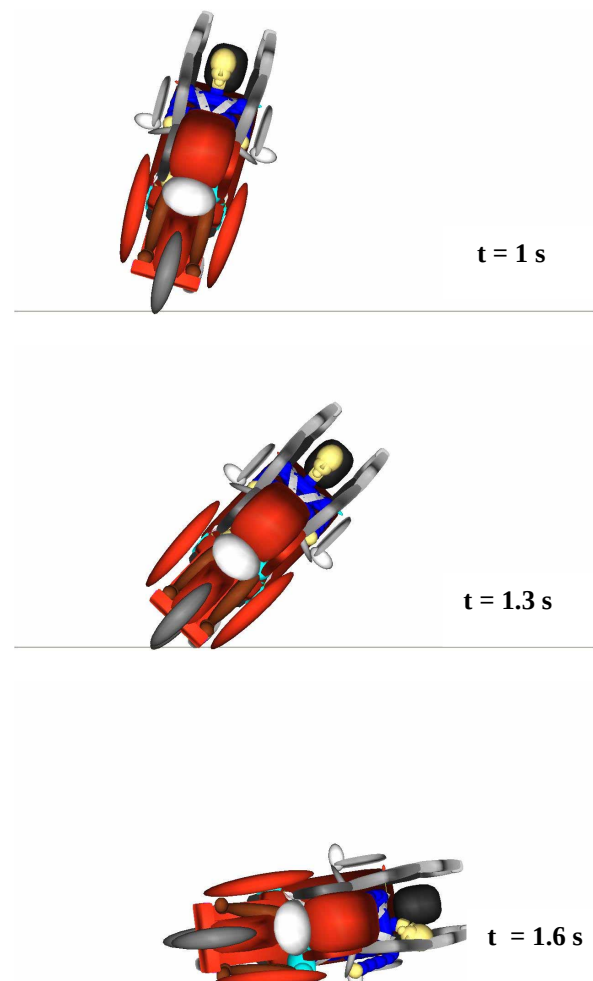
**Figure 8. Simulation: Lateral fall test**

There are also two replaceable deformation elements attached to the shoulder hoops. These have been designed to meet the requirements of the lateral fall

test which was specially developed for this type of vehicle (Figure 8). These foam elements reduce kinetic energy, lessening the stress on the rider's head and neck and ensuring a safety distance of 70 mm between head and road.

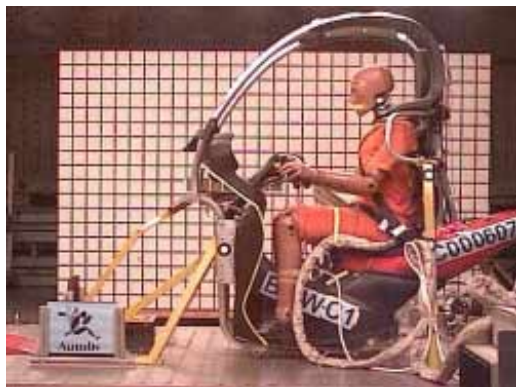
**Figure 9. Sled test set-up**

The stability of the restraint system components was checked by sled test (Figure 9) and the restraint characteristics optimised for 5th% female, 50th% and 95th% male.

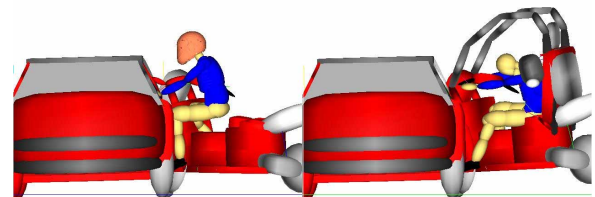
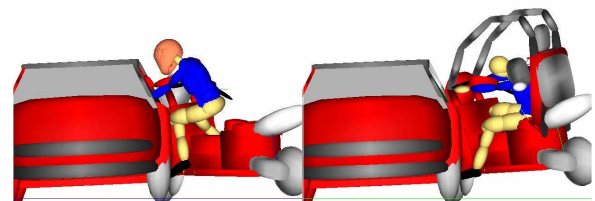
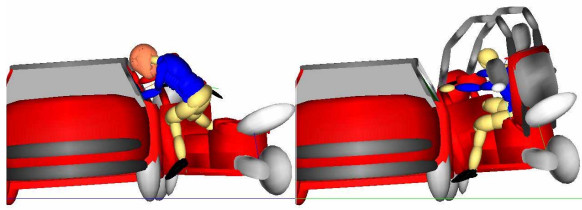
**Figure 10. Computer simulation: C1/C0  
(t=90 ms, t=110 ms, t=130 ms)**

A comparison was made between a two-wheeler with safety system and one without (Figure 10). The comparison vehicle used in this case was a C1 without roof frame, safety belt or deformation elements (C0). The dummy riding the C1 was modelled without a helmet and that on the C0 with a helmet.

For the C1, the resulting injury risk/benefit ratio was 10%. Included in the 10% are AIS 1 injuries caused by the belt at higher impact speeds.

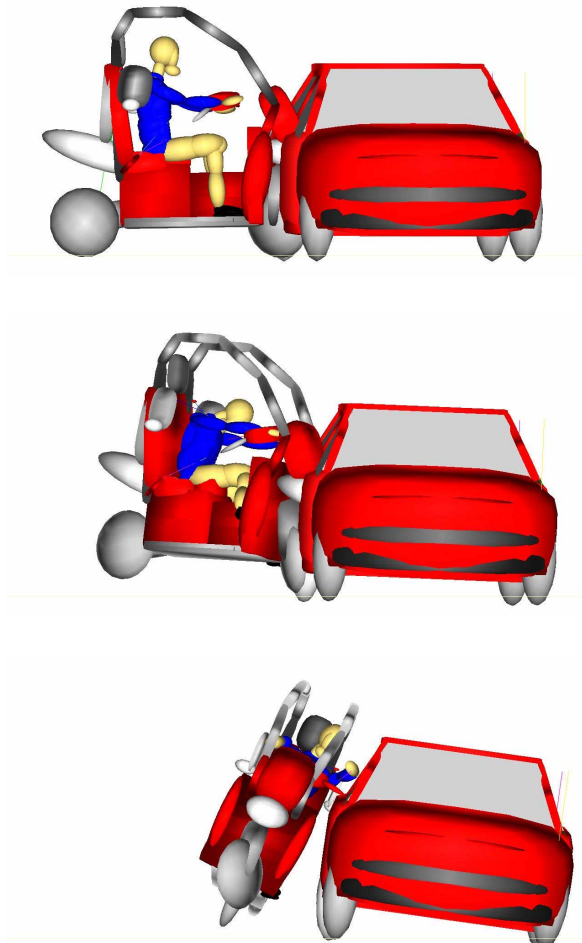
**Figure 11. Computer simulation  
(t=40 ms, t=110 ms, t=260 ms)**

The simulation was validated on the basis of the 7 crash tests described in ISO 13232, Part 2 and carried out with the C1 (Figure 11). Thereafter, for the risk/benefit analysis, 200 different types of collision with a passenger car over a period of up to 5000 ms were simulated and evaluated. The 200 configurations were based on accident analysis data and are likewise described in the ISO 13232 motor cycle crash standard. At 5000 ms, the lateral fall following the initial collision was also taken into account.

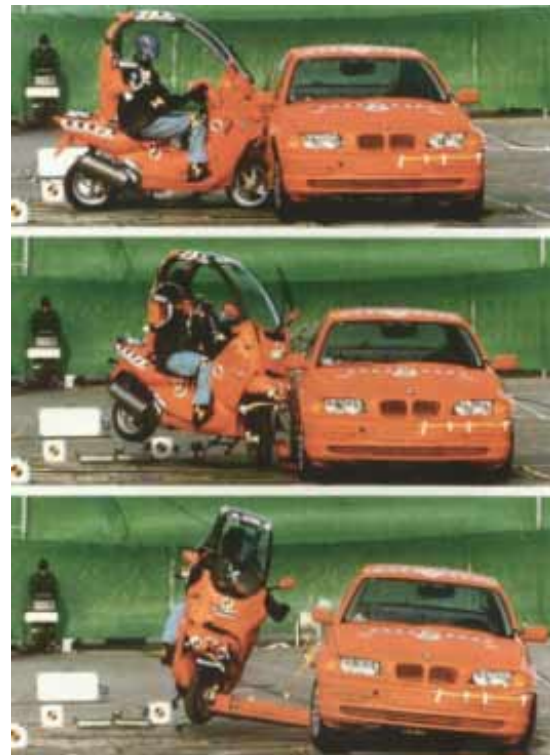
**Figure 12. Crash test ISO 143  
(C1: 48 km/h, car: 24 km/h)**

The potential protection for the rider results from a high-stability frame structure, the quality of the deformation characteristics, high-performance restraint systems and the manner in which these features are harmonized with one another. This harmonization of components was achieved through crash testing. The C1 was subjected to a comprehensive crash test program. The ISO 13232 motorcycle crash procedure formed the basis for the tests (Figure 12). Additional crashes such as a frontal collision with a wall, a rear-impact collision and a simulated single-vehicle accident rounded off the overall picture.

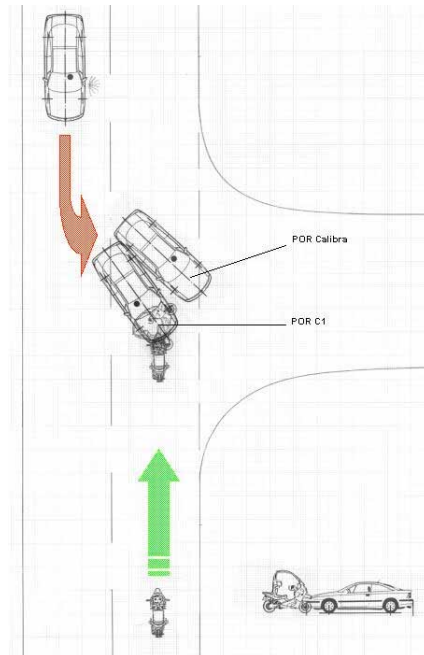
**Figure 16. Sketch of frontal collision**

A motor car turning left from a main road into a side road failed to notice the oncoming C1. A frontal collision took place roughly in the centre of the traffic lane. The C1 collided with the car at an angle of approx. 140°. During the accident, the C1 rolled into the windscreen of the car (Figures 16-17).

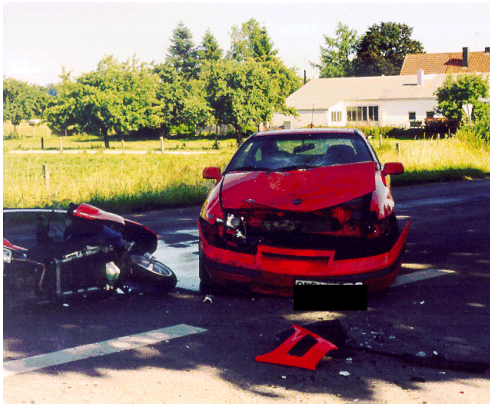
**Figure 18. Final positions and damage to car**

Figure 18 shows the final positions and above all the damage to the Opel Calibra. The entire front end including bumper, wings, bonnet and the supporting structure behind them are badly damaged. The deformed windscreen of the Calibra is also visible.

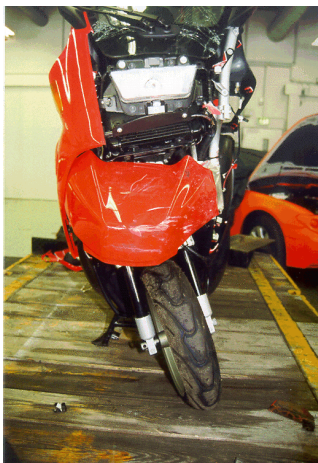
**Figure 19. Damage to the C1**

The pattern of damage to the C1 (Figure 19) is highly positive. Here too, the entire front end is damaged and has thus absorbed an appropriate amount of energy. The frame structure on the other hand exhibits only slight deformation.

The safety elements incorporated in the C1 have demonstrated their effect. The front-end containing the crash element is deformed and has thus absorbed the energy. The passenger cell remained intact. The

belt system has held the rider within the protective frame structure. As the vehicle fell on its side, the shoulder hoop has prevented the rider striking the road surface and suffering serious injuries, in particular to the head and thorax area.

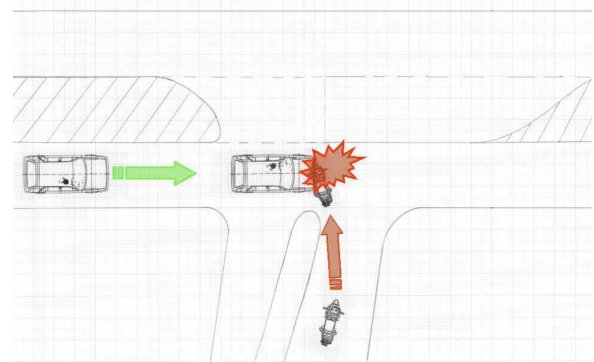
**Figure 20. Sketch of side-on collision**

The C1 rider wished to turn left into the main road and ignored the fact that a Golf had the right of way. The Golf collided head-on with the side of the C1 (Figure 20).

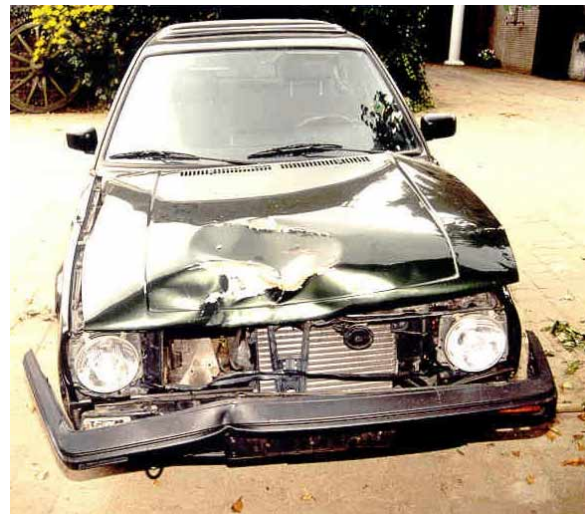
**Figure 21. Damage to the Golf**

The Golf suffered damage to the bumper, bonnet, radiator grill and wings. The deepest static penetration was approx. 150 mm (Figure 21).

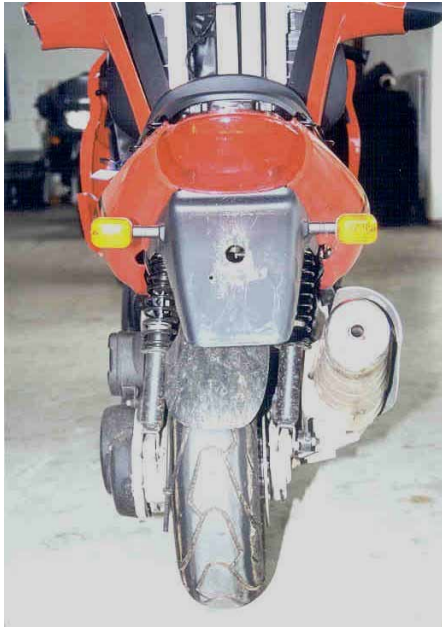
**Figure 22. Damage to the C1**

At first sight, no major damage is visible to the C1. Trim parts on the left-hand side are damaged or broken. The left exterior mirror is torn off, the windscreen is cracked. The fact that a considerable energy displacement has taken place is however clearly evident from the rear view of the deformed frame of the C1 (Figure 22).

With the exception of the crash element, which due to the accident configuration was unable to influence the outcome, here too the safety elements protected the rider from more serious injuries. The safety cage remained intact and the belt system retained the rider in the frame. The shoulder hoop prevented the rider from coming into contact either with the Golf or with the road surface.
